MARCH 19, 1997

BUILDING PERFORMANCE ASSESSMENT:

# *Hurricane Fran in North Carolina*

OBSERVATIONS, RECOMMENDATIONS,  
AND TECHNICAL GUIDANCE

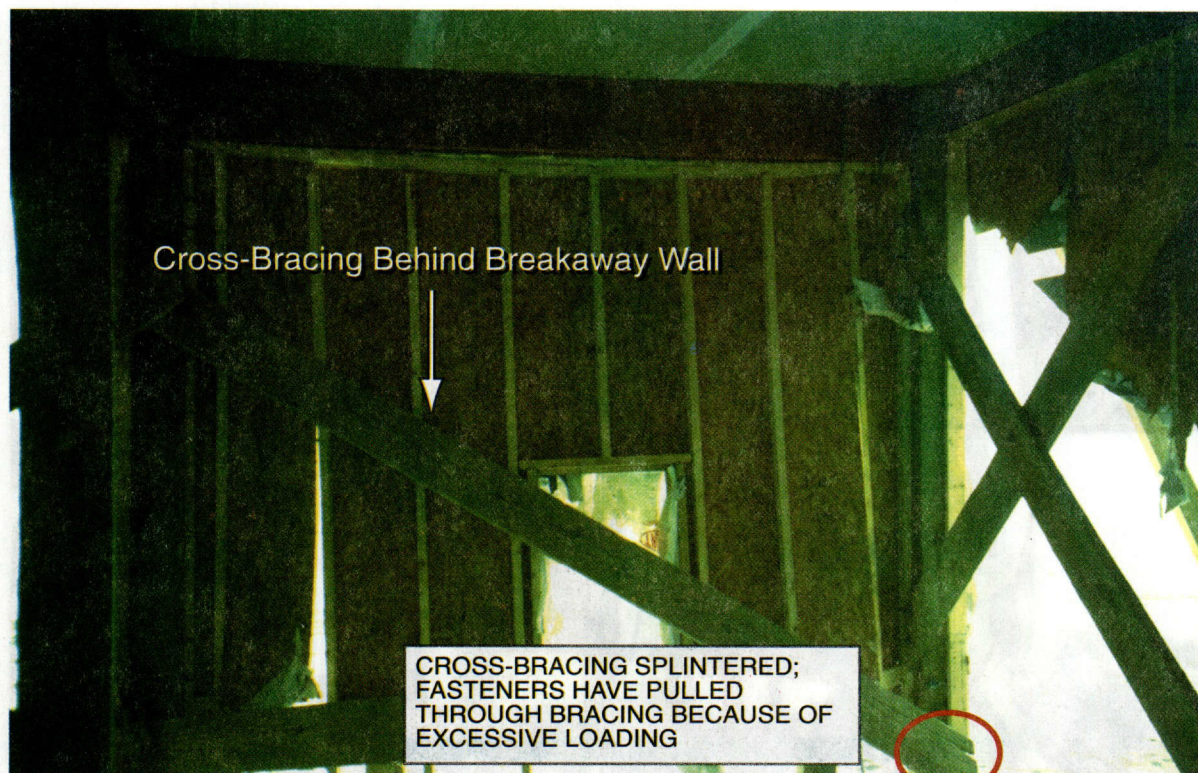
On a few structures, breakaway wall panels were observed to have been installed directly seaward of cross-bracing (see Figure 2-29). When the panels broke away under the loads imposed

by flood waters, they moved back and came to rest vertically against the cross-bracing. As a result, the vertical surface exposed to velocity flow, breaking waves, and debris impact increased tremendously and so did the corresponding loading on the cross-bracing. For cross-bracing installed across a typical 8-foot span between pilings, the resulting loading far exceeds the bending moment capacity of 2x or 3x wood braces in the narrow dimension. As a result, the cross-bracing often failed.

Figure 2-29 Improper installation of breakaway walls (on the seaward side of cross-bracing) resulted in failure of cross-bracing. Note breakaway wall pushed against cross-bracing.

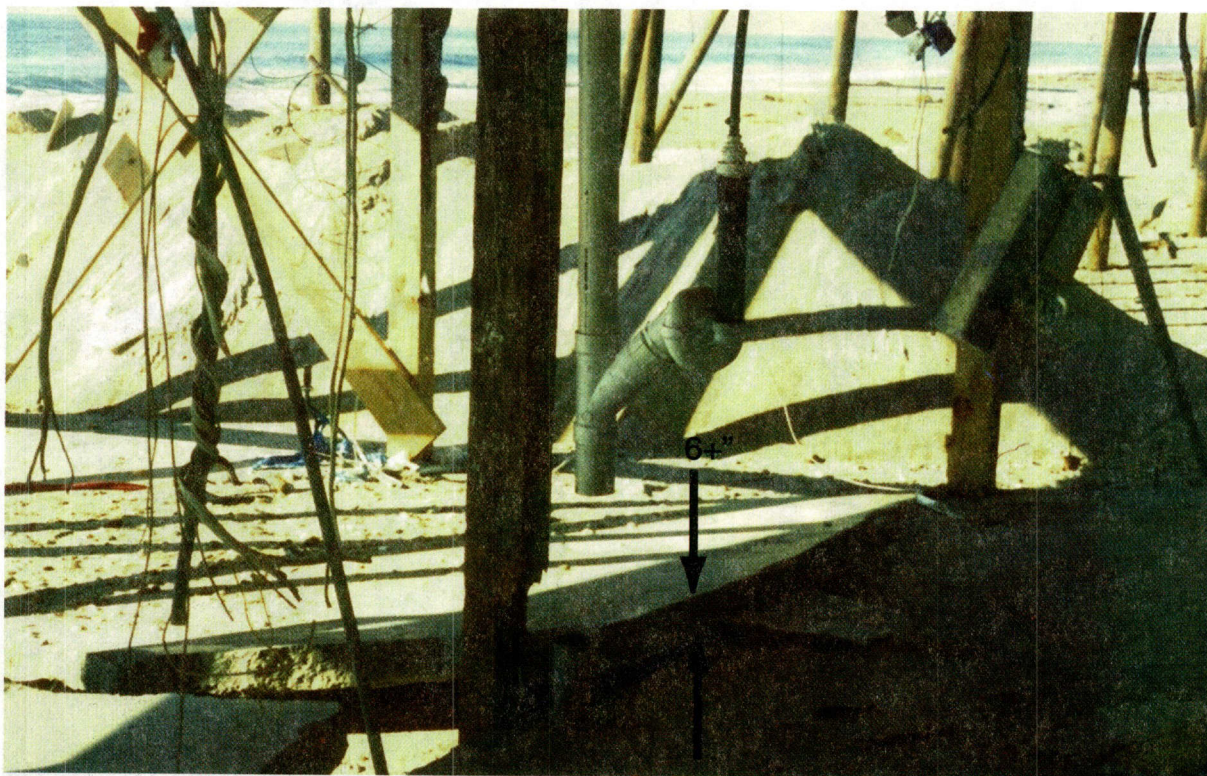
Figure 2-30 Example of unnecessarily thick slab.

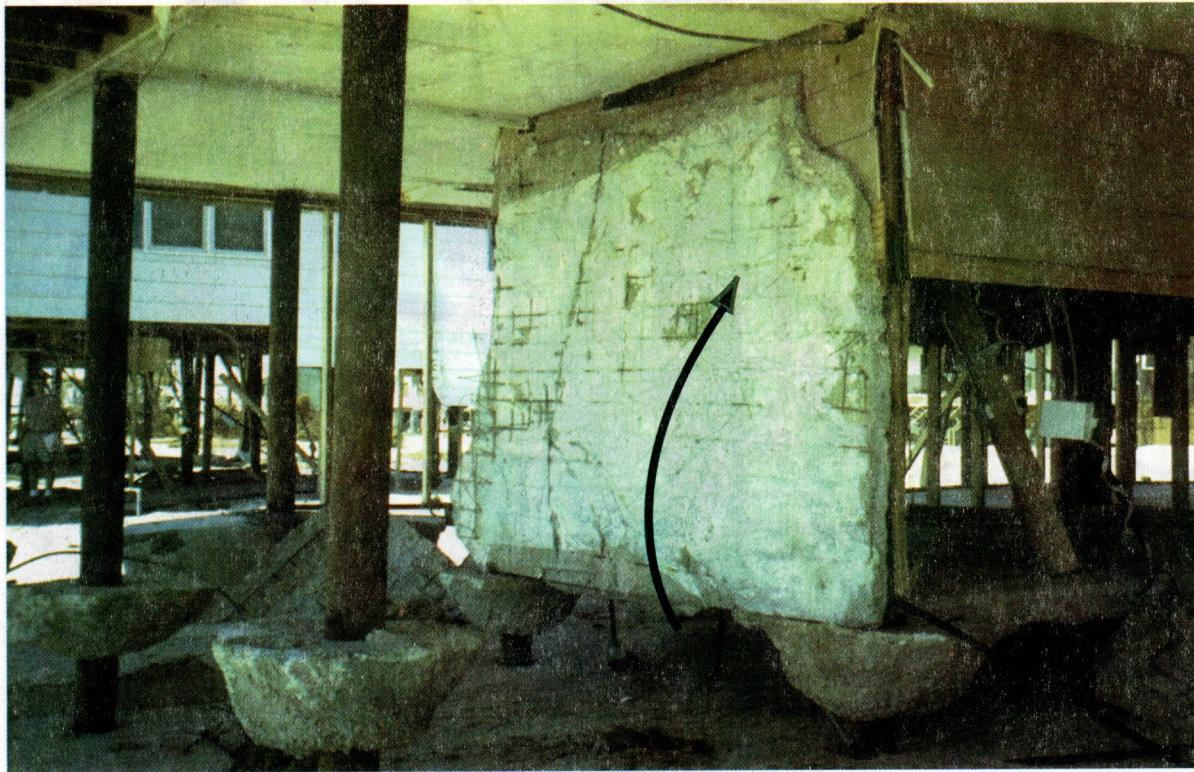
**Figure 2-31** *Concrete slab-on-grade flipped up, probably by wave action, came to a rest against two foundation members, generating large, unanticipated loads on the foundation. Note slab is supported on concrete collars around piles and contains wire mesh.*

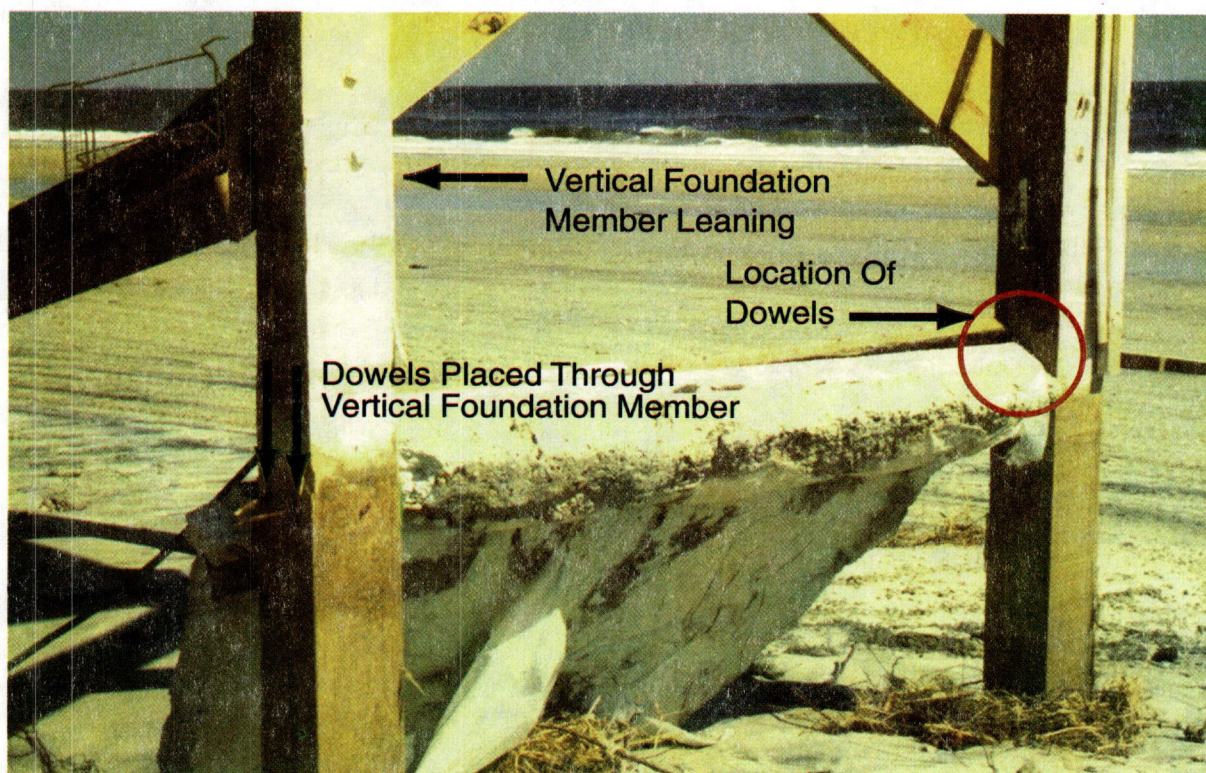
**Figure 2-32** *Use of steel dowels to tie slabs to vertical foundation members prevented the proper breakup of slab. A portion of the slab was left attached to the piling, resulting in large, unanticipated loads on foundation members. Note leaning vertical member, on right.*

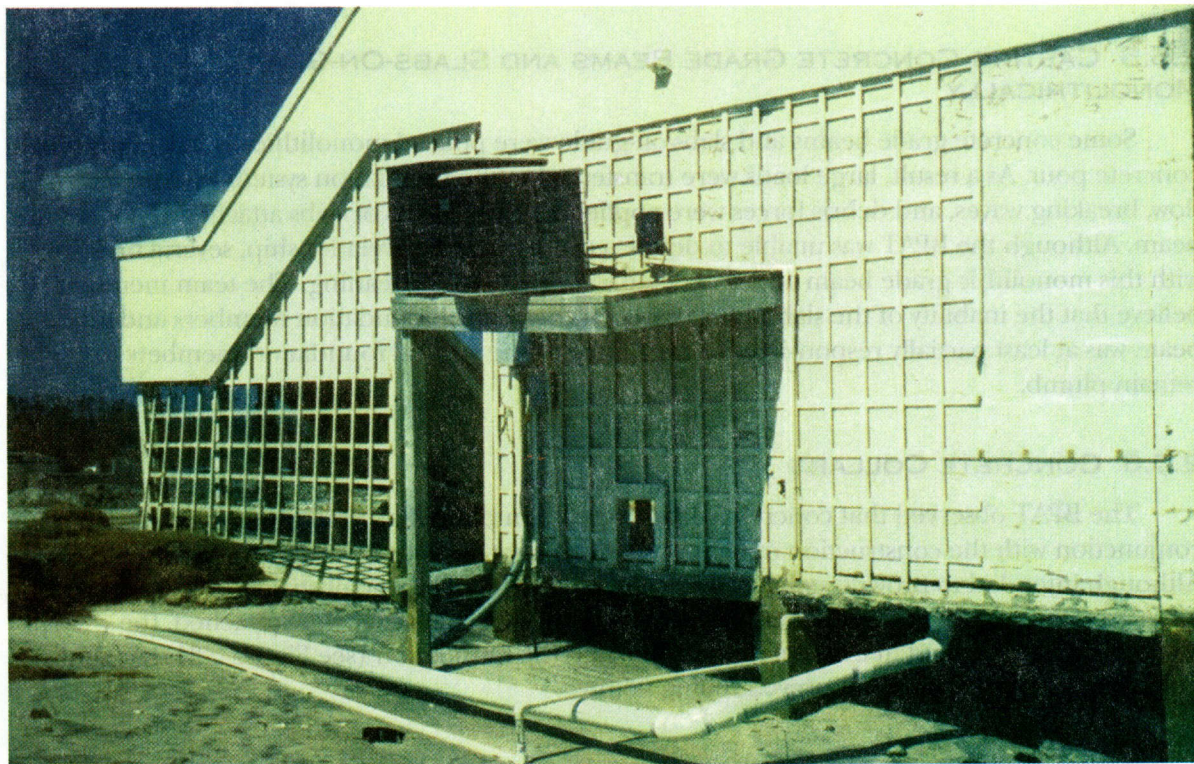
Figure 2-33 Air conditioning / heat pump compressor platform leaning because erosion and scour caused loss of one supporting column.

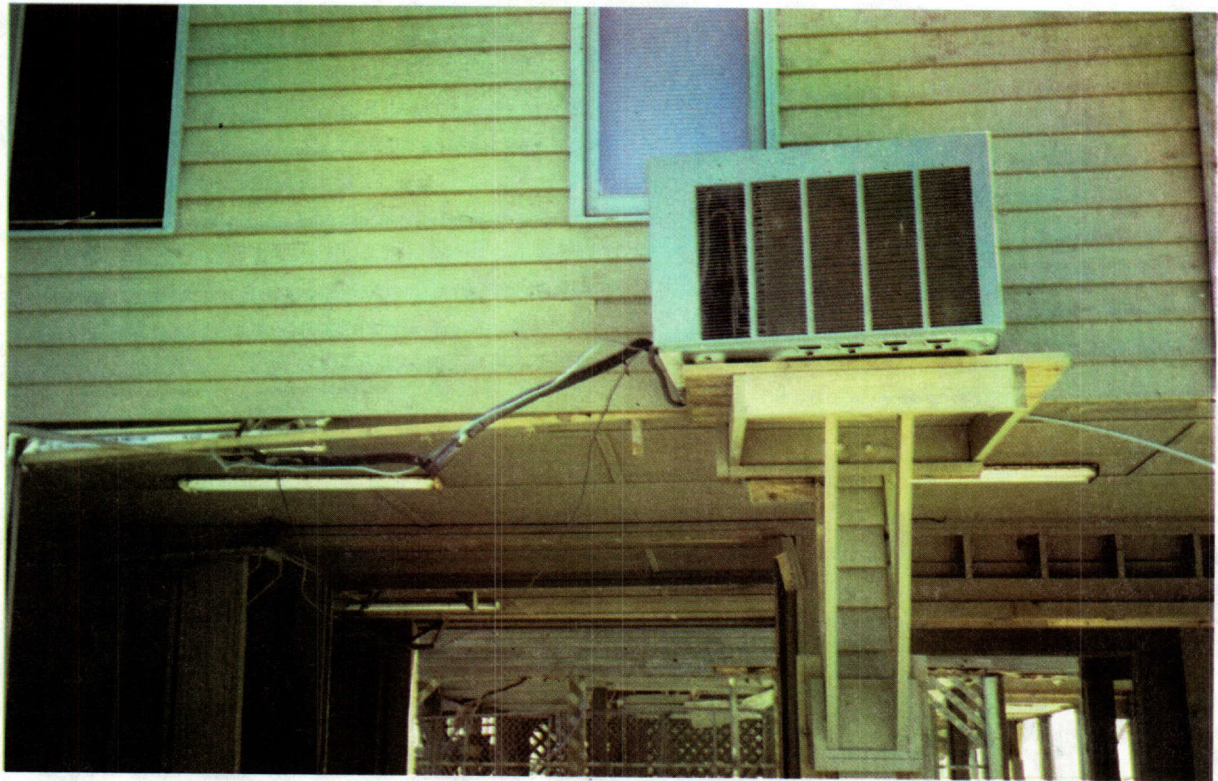
*Figure 2-34 Although the air conditioning/heat pump compressor platform on this oceanfront house was adequately elevated with cantilever bracing, the compressor was almost pushed off the platform by wind because of the lack of the necessary attachment.*

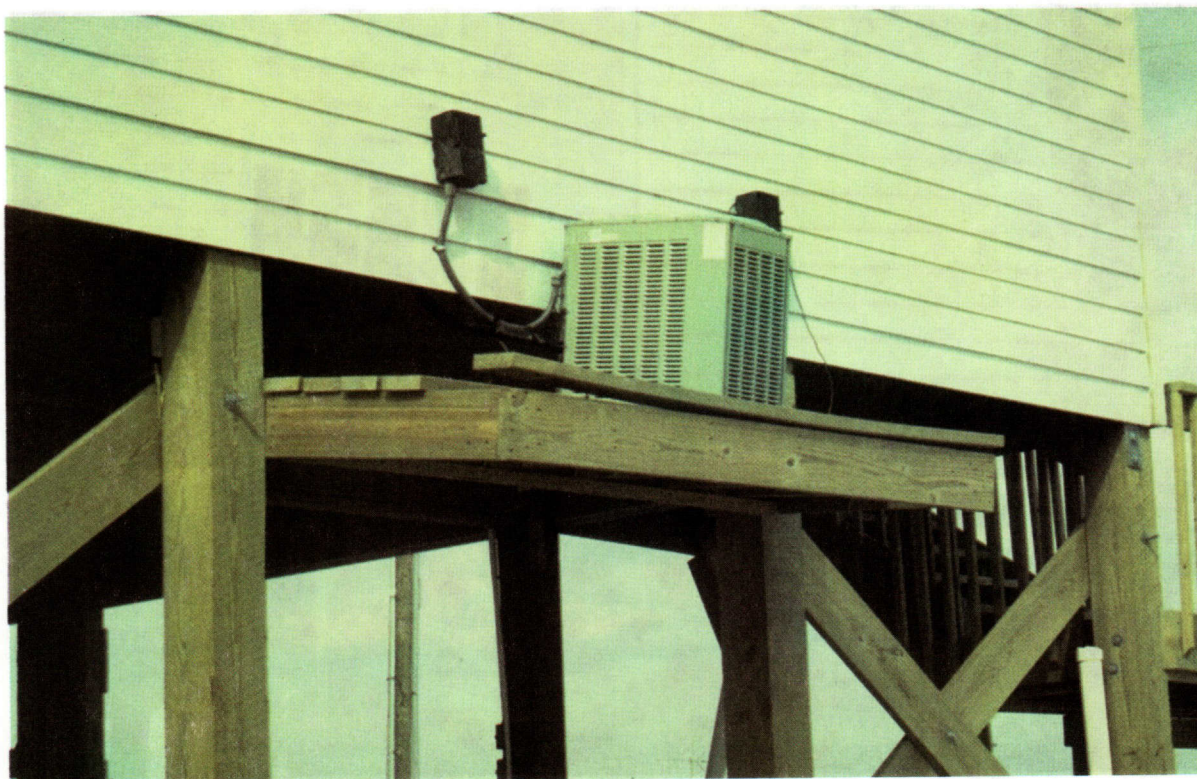
Figure 2-35 Air conditioning / heat pump compressor platform leaning because scour caused loss of two supporting posts.

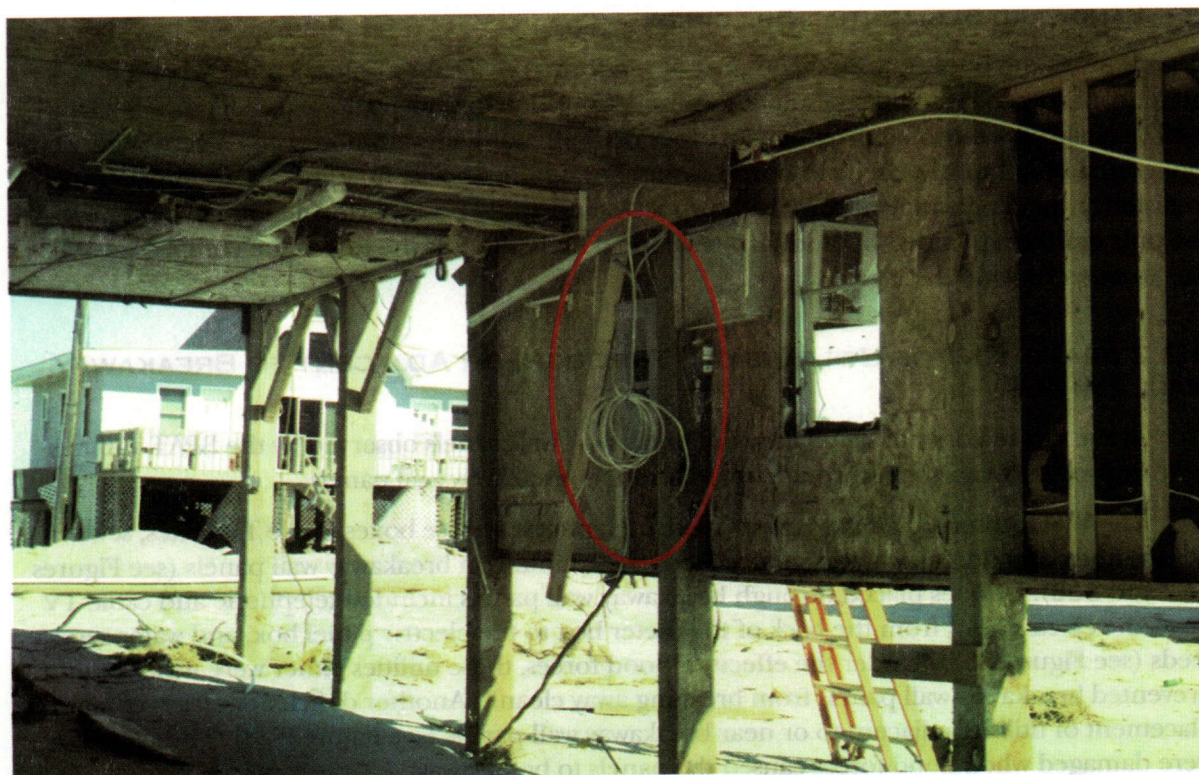
Figure 2-36 Example of utility component (electric panel box) installed on a breakaway wall panel.

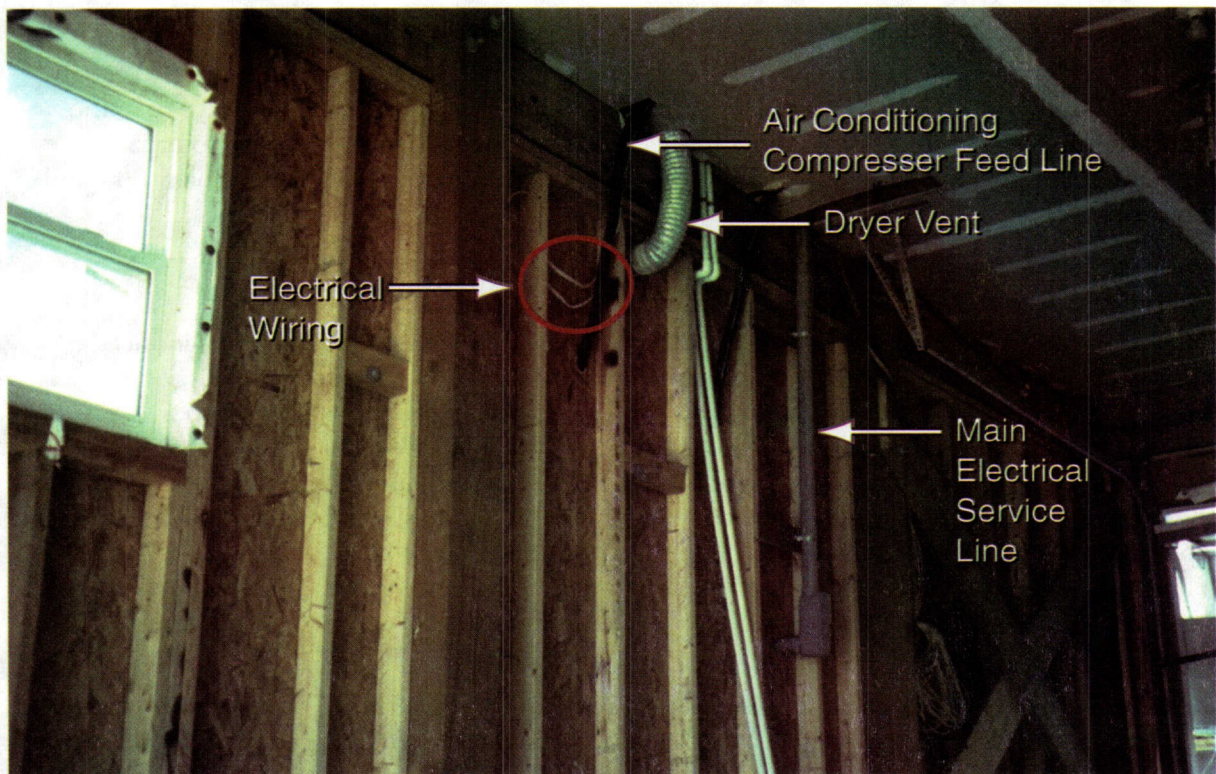
**Figure 2-37** Utility components (dryer vent, air conditioning compressor feed line, main electrical line out of meter box, and electric wiring) penetrating breakaway wall panel.

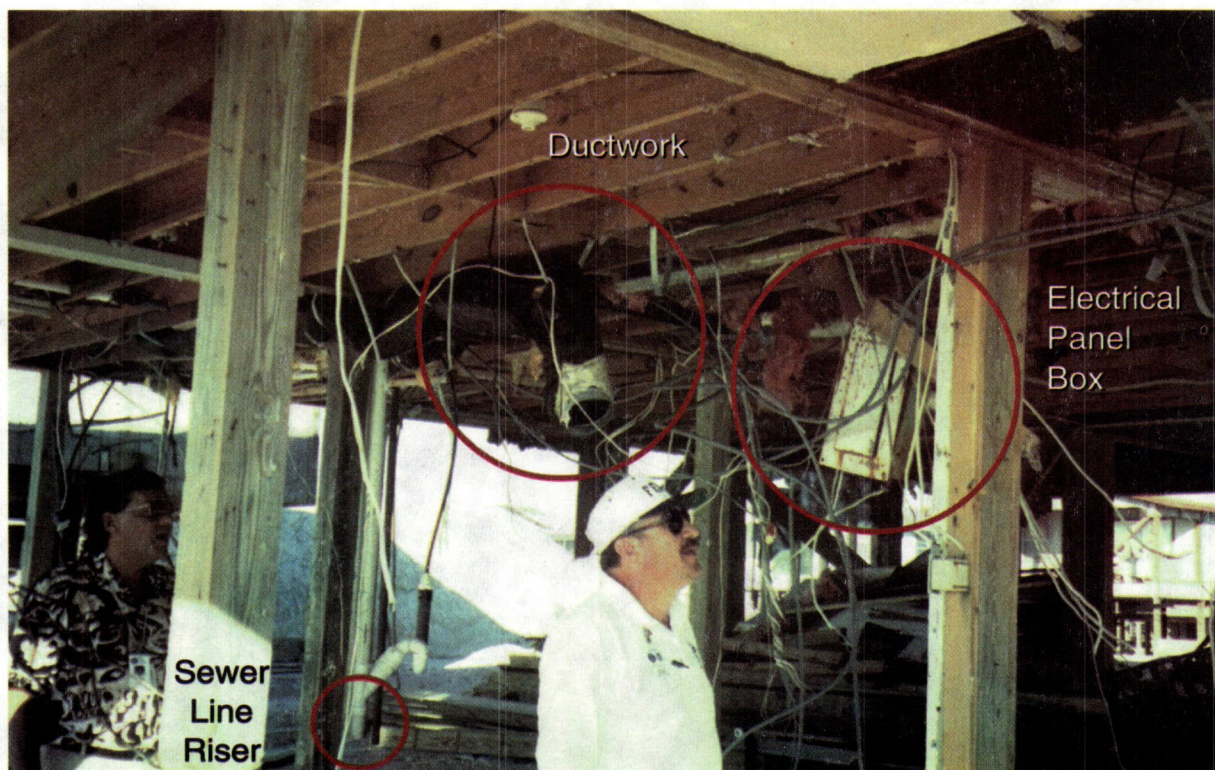
**Figure 2-38** These utility components (wiring, electric panel box, ductwork, and sewer line) were installed adjacent to breakaway wall panel and were damaged when the walls broke away. Note broken sewer line riser pipe on seaward side of piling.

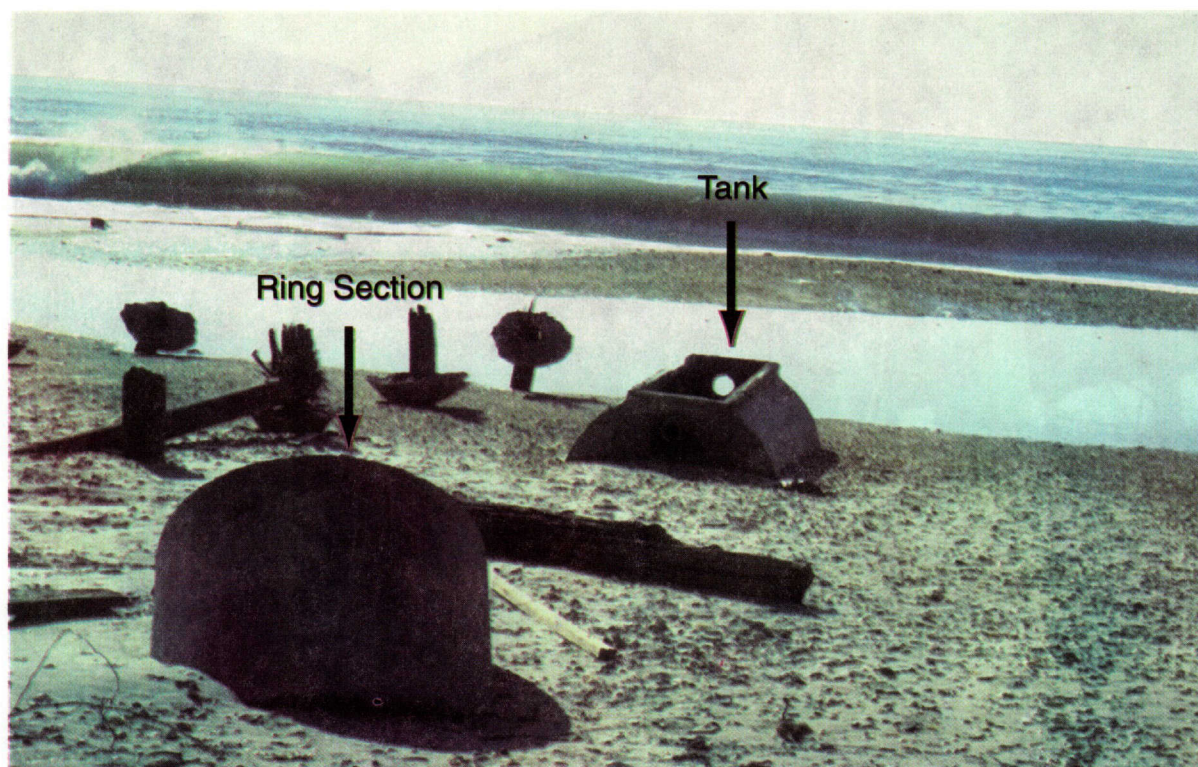
Figure 2-39 Oceanfront erosion and scour unearthed and damaged septic tanks and systems. Note precast ring section and precast tank.

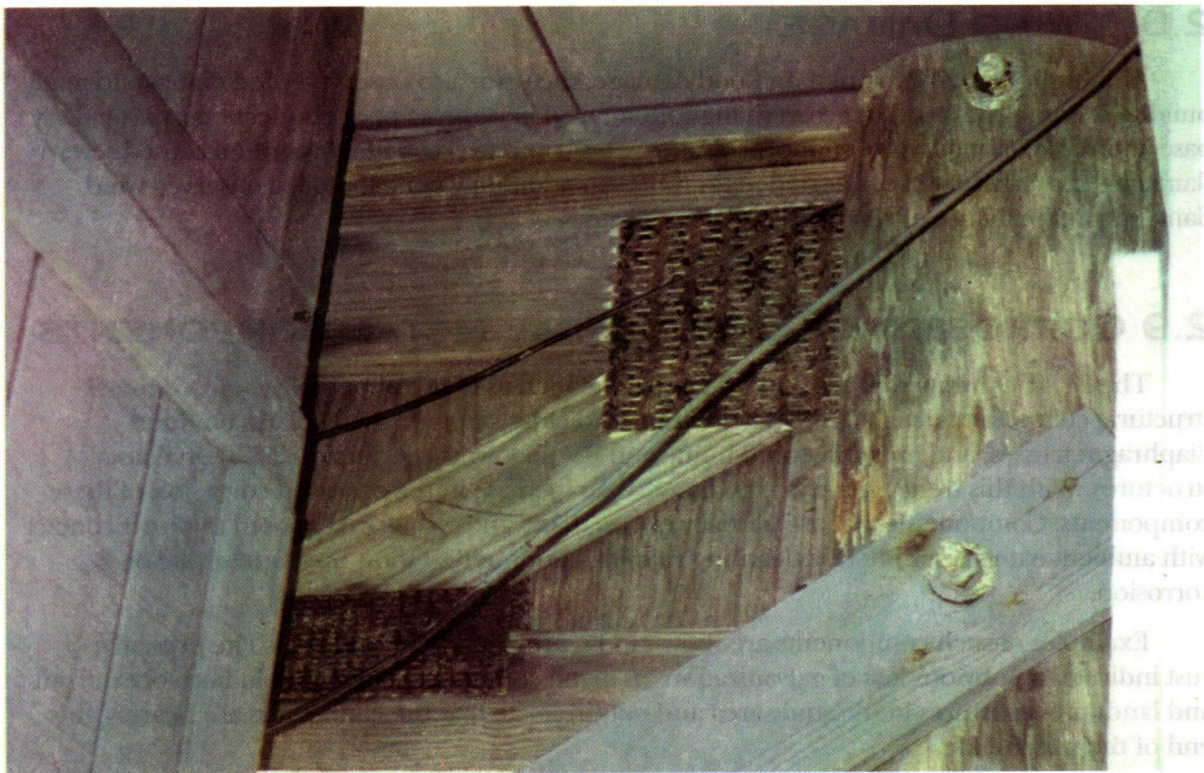
*Figure 2-43 Corrosion of galvanized floor truss plates was observed in many buildings.*

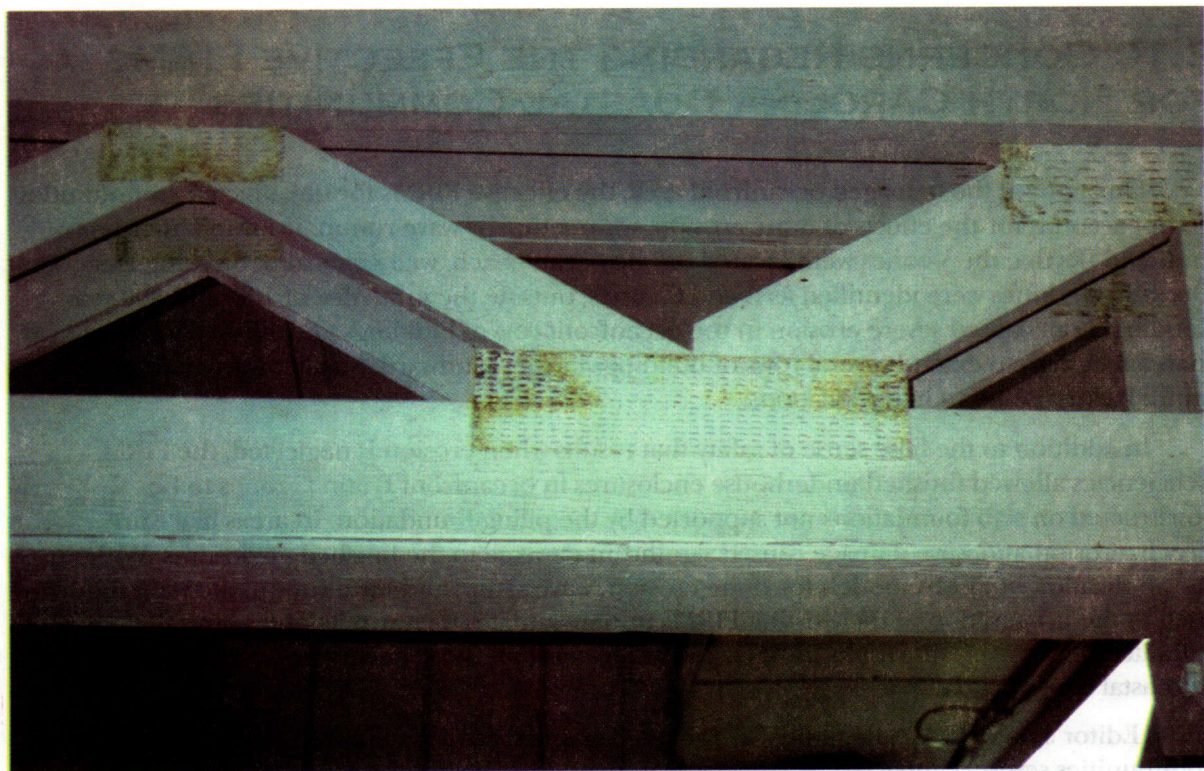
*Figure 2-44 Corrosion of galvanized floor truss plates was observed in many buildings. Note that painting does little to slow the process of corrosion in coastal environments*

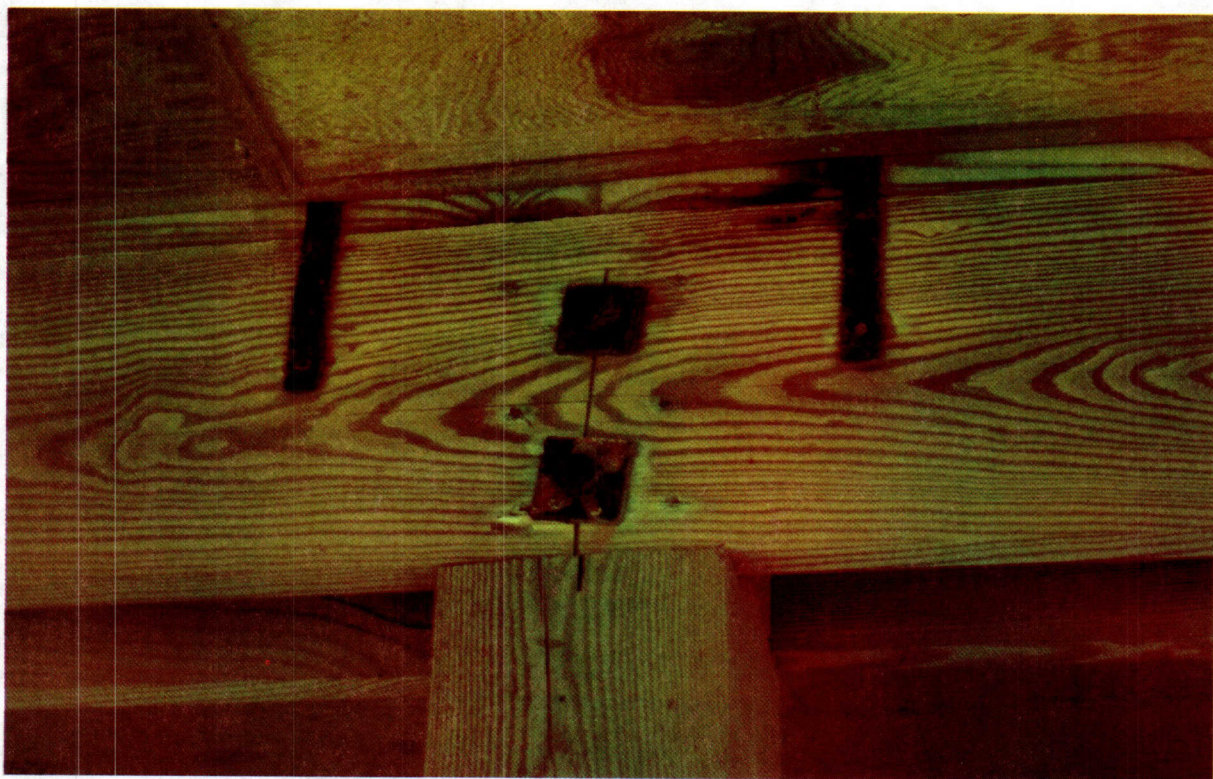
Figure 2-45 Corrosion of hurricane straps and steel plates was also observed in many locations.
